# Major Inspection & Failure Analysis

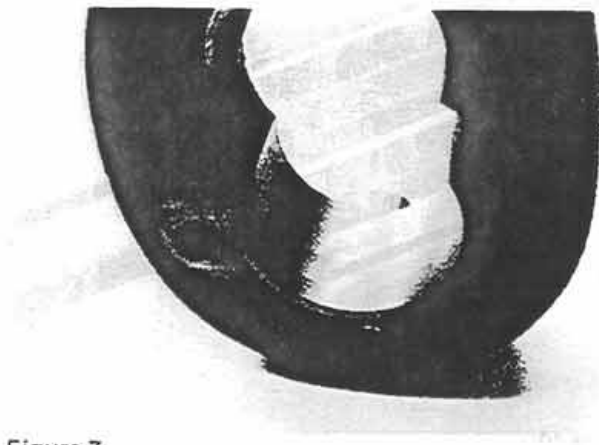
Figure 7:

Here is a typical pump housing with gear bores that display a normal appearance. During the factor test and initial break-in period, the tips of the gear teeth touch the suction side of the gear bores to form a continuous positive seal. It is common to note some material removal from the gear bores until the gears have fitted themselves. (See Fig. 7)

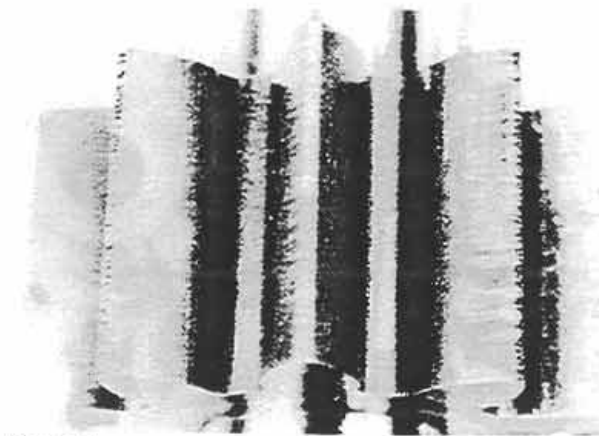
Figure 8:

The crowns or tips of the gear teeth will have an appearance to match the gear bores' finish. Also on each gear tooth there is a load-bearing face and a non-load bearing face, this is determined by direction of rotation. Usually the drive gear will have a razor-like edge where the non-load-bearing faces and crowns meet. This is also a normal characteristic. The driven gear, however, will have a lesser edge because it has less chance to collect on load-bearing side of the gear-tooth as the force of the drive gear keeps it worn off. (See Fig. 8)

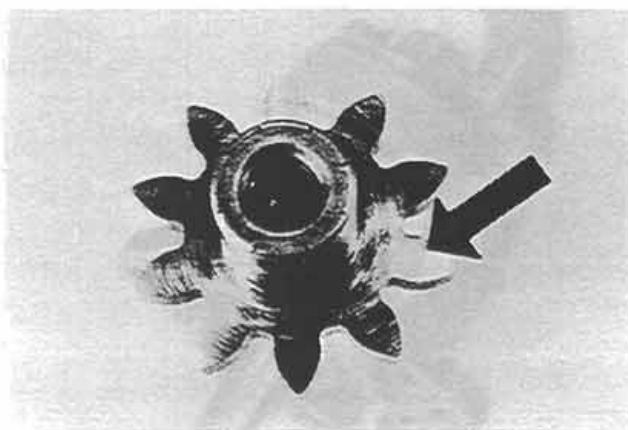
Figure 24:

To identify the fine abrasive wear caused by dirt, we must understand that many of these particles are too small to be visible. Oil containing these particles may look clean, but may be the cause of pump wear and subsequent failure. We are able to determine this by inspecting the finish on all the wear surfaces. If this type of contamination is present, we will note a dull finish that looks like fine sandblasting on the surfaces that should have a high polish. For example, the thrust faces of the gears. (See Fig. 24)

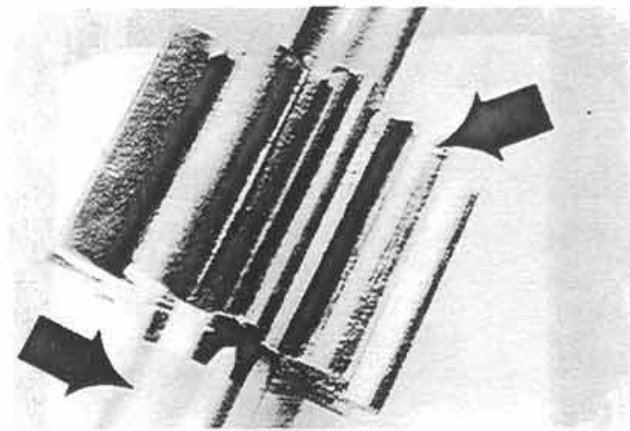
Figure 25:

The shaft journals will have a dull finish the length of the bearing surface. It may appear as if very fine sandpaper was used around the shaft. The load-bearing sides of the gear teeth will have a similar appearance. (See Fig. 25)

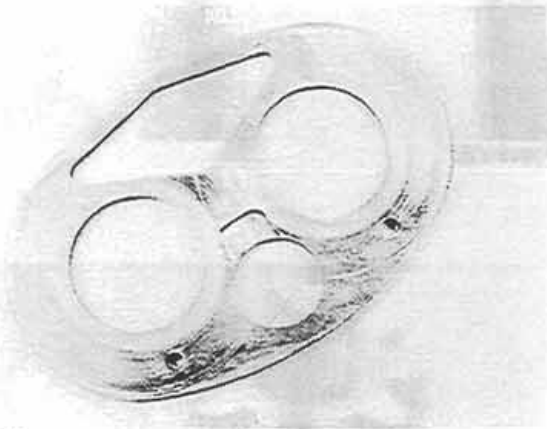
Figure 26:

The machined relief on the pressure plates normally has a sharp edge. If the edge looks as if it's been rounded, then dirt contamination will apply. The degree of damage to a normally polished surface will depend upon the size and concentration of dirt particles. Until the pump fails completely, the worst damage found is usually minor scratches because each time the particles pass through, they are crushed finer until they are nearly the same as a lapping compound. (See Fig. 26)

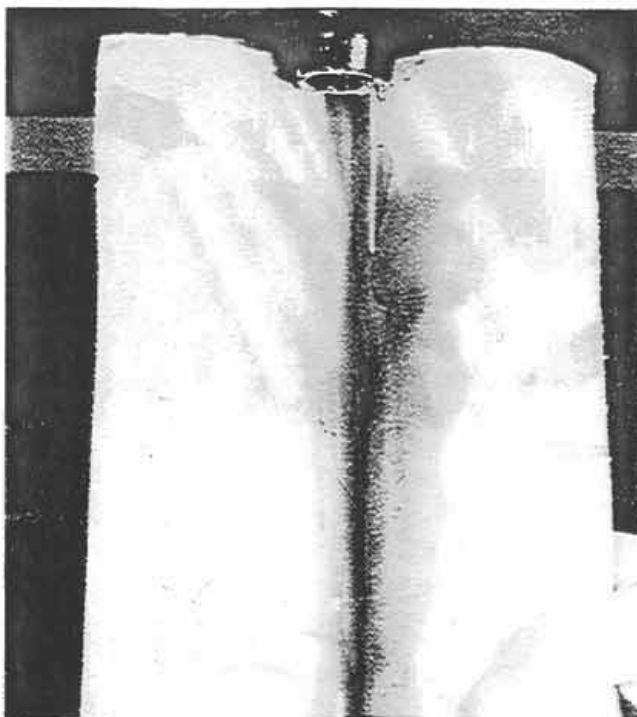
Figure 28:

In a system which is contaminated with particles of wear metal, the conditions inside the pump will be different since most metals are tougher than dirt. The presence of metal particles in the oil can be seen with a bright light. If you look close, a glittering reflection can be seen through the oil. Each one of these reflective particles has multiple cutting edges and the amount of damage caused will be in relation to their size. Once damage has begun, the metal content of the oil will increase as the system is used. (See Fig. 28)

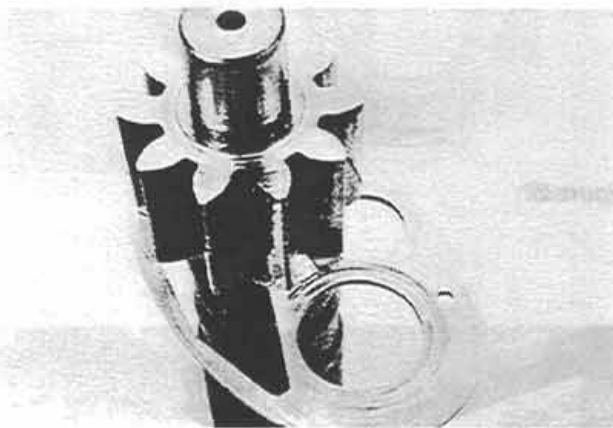
Figure 29:

The same areas of the pump are affected as before, but will indicate grooving instead of sandblasted finishes. If metal particle size was fairly large, scoring and some discoloration may be found. Gear thrust faces will have damage that matches the same areas on the pressure plates, mainly the tooth area of the gear. (See Fig. 29)

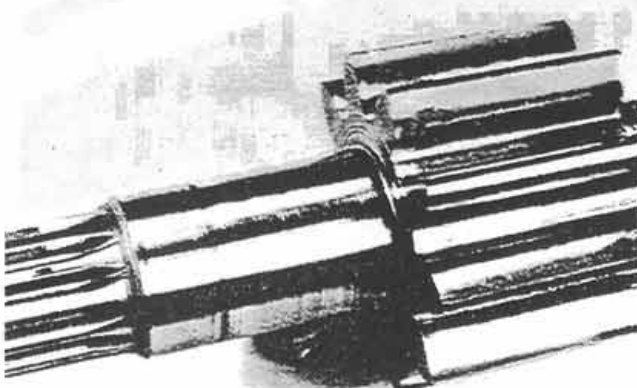
Figure 30:

Shaft journals will have scoring around them regardless of the type of bearing used. (See Fig. 30)

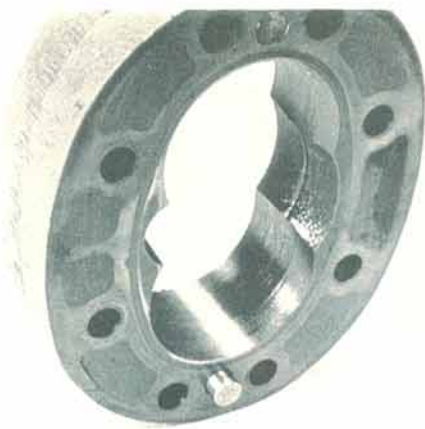
Figure 31:

The gear bores of the pump housing will have grooves cut on the inlet side. You can compare the bore finish on the inlet and discharge side of the housing. Usually, when the damage is this far advanced, pump performance is very poor due to the large clearance between the gear tooth crowns and pump housing. (See Fig. 31)

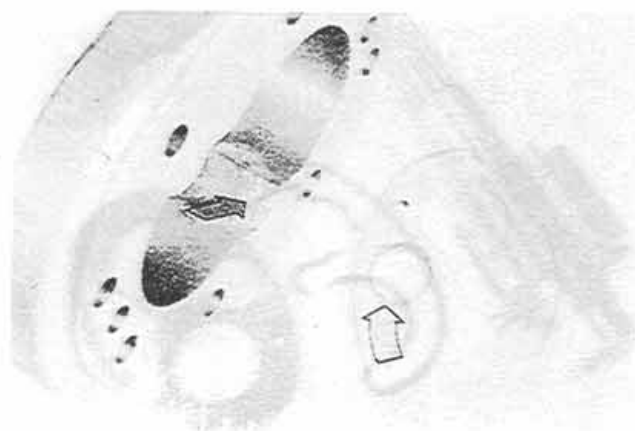
Figure 35:

This action in turn will erode metal from parts having the softest and most porous materials. In this case it would be the pump housing and pressure plates in the discharge area. The affected areas of the pump housing and pressure plates will have the appearance of having microscopic bits of metal pulled out, leaving many tiny holes. (See Fig. 35)

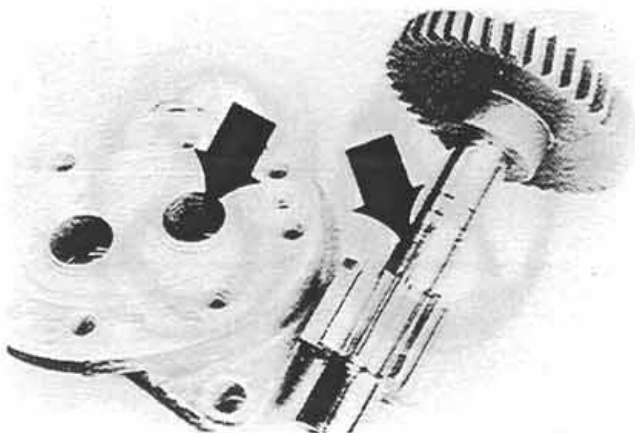
Figure 36:

Poor lubrication of the pump bearings is influenced when bubbles are present in the oil. The most critical are pumps equipped with plain bearings when the engine drive gear is supported directly on the pump shaft. Because of the greatest load, combined with the conditions described, it is likely for extreme bearing wear nearest the engine gear with or without much influence upon the other bearings. (See Fig. 36)

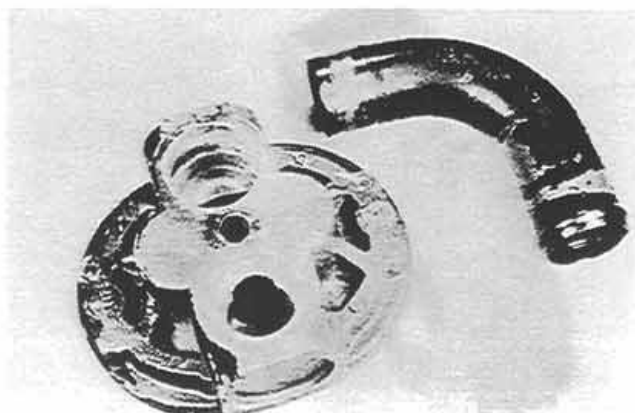
Figure 37:

Excessive temperatures may cause aeration of the oil due to a chain reaction. Some pump models have a steel suction tube pressed into the pump cover and the joint is sealed with a special epoxy. When the hydraulic system is abused by either improper accessories or high usage of the relief valves, we know the oil will absorb heat. If the temperature becomes too high, the aluminum pump cover may expand away from the steel tube and loosen the epoxy sealant. This can disguise a potential fault when the system cools down and, in the meantime, it can fool a good technician looking for an air leak. (See Fig. 37)

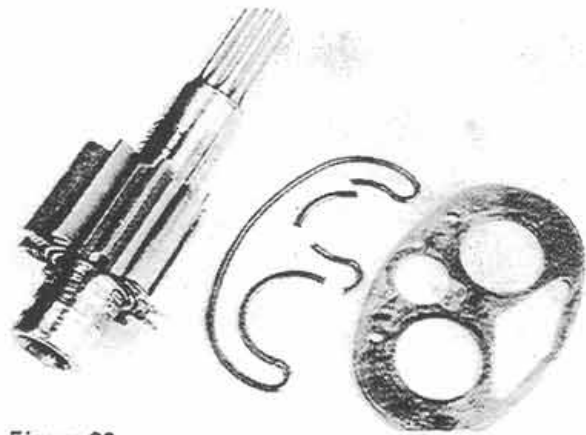
Figure 38:

If a pump is run in an overheated condition, the heat will scorch oil onto the pressure plates to give a black color. The gears and shafts will usually have black streaks on surfaces that otherwise show little or no damage. The pump seals, if not already destroyed, will be brittle. (See Fig. 38)

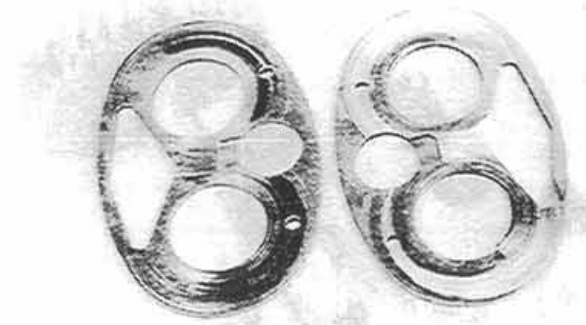
Figure 39:

When we see pressure plates that have their bearing material smeared, welded or separated from their backing, then we know that lack of oil was the cause. The oil level in the reservoir may be low enough to supply the pump only part of the time, or a large air leak is present somewhere in the suction line. (See Fig. 39)

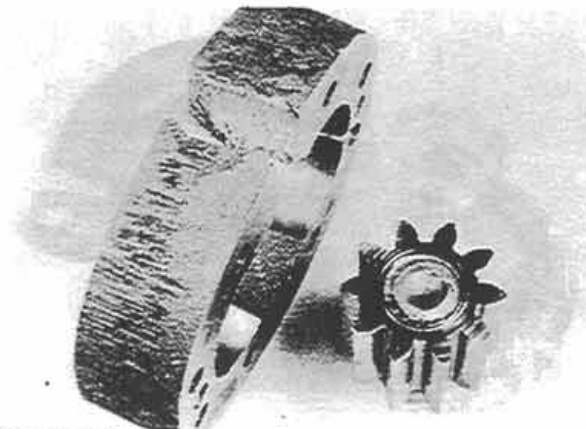
Figure 40:

The pump housing and drive shaft are parts most likely to become damaged if the pump is overloaded by pressure. If relief valves fail to function, a surge of high pressure can cause breakage of the driveshaft or pump housing. The same type of shaft damage may take longer to happen if the relief valve setting is too high or if the pump is incorrectly mounted to the engine when a spline drive is used. (See Fig. 40)

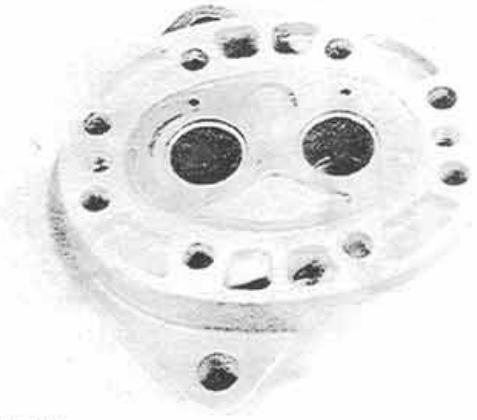
Figure 41:

Many pumps have failed or lacked performance simply by careless reassembly or installation. Here are a few examples of common incidents. Pressure plates, if installed backwards, will allow the plate seals to wash out, thus permitting fluid flow from the discharge to enter the inlet chamber. Continued operation causes erosion of the end cover near the bearing bores. (See Fig. 41)

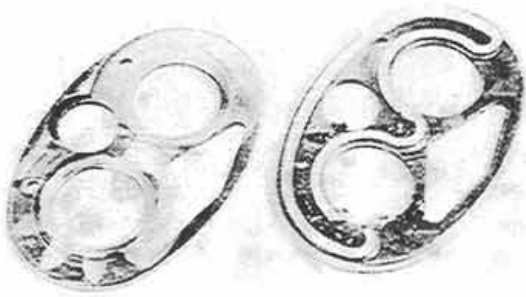
Figure 42:

Gear thrust faces can cut into the pressure plate if the seals under the plate aren't properly positioned in their slots. The drive shaft on some pumps has a spline drive to fit the engine coupling. If the drive shaft does not enter the coupling freely to its proper length, the same result will be seen. (See Fig. 42)

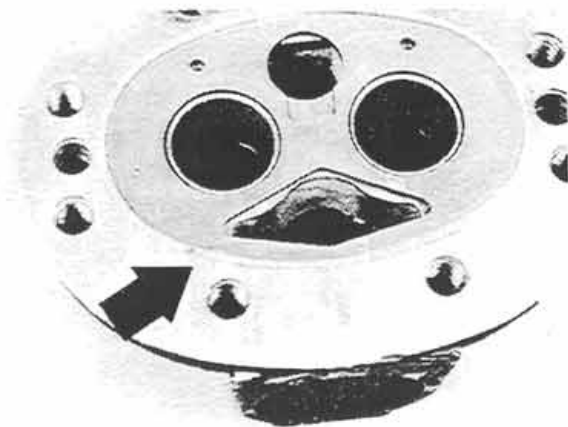
Figure 43:

External leakage is usually the result if the end cover seals become pinched or if foreign material is caught between the end covers and pump housing at reassembly. (See Fig. 43)

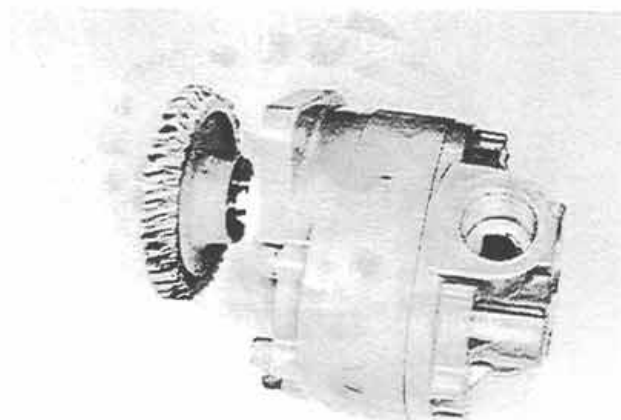
Figure 44:

Pumps which have the engine gear directly on the pump drive shaft must be mounted squarely and torqued evenly to the engine flange. Otherwise edge loading can cause failure of the engine gear teeth. (See Fig. 44)
