# Major Inspection & Failure Analysis

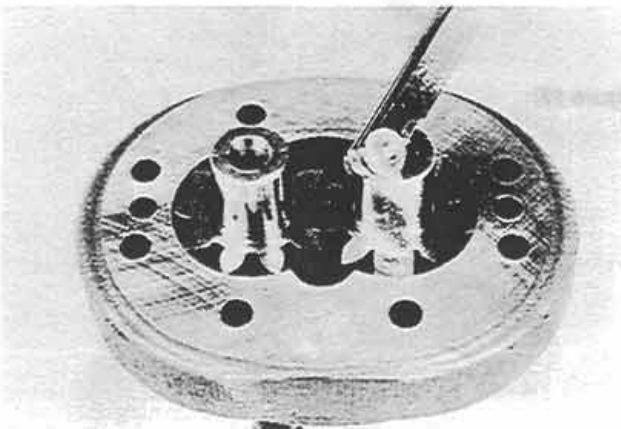
Figure 15:

The amount of wear on a mating bearing and shaft is in direct proportion to the amount of excessive material that the gears remove from the pump housing. This condition can occur if the bearings wear after pump break-in. To determine the extent of wear, temporarily fit the gears in the pump housing and apply thickness gauges until you find the one that takes up all the clearance, as shown. A maximum of 8 thousandths of an inch is permitted in a good used pump. We must stress that if this dimension is exceeded, we must replace the bearings and pump housing. (See Fig. 15)

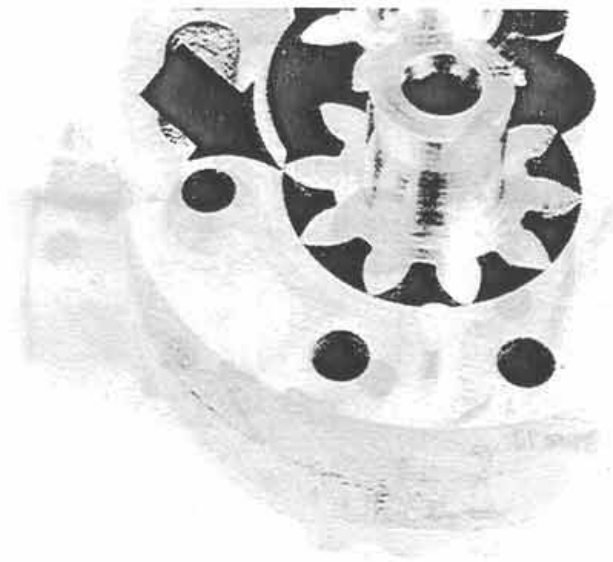
Figure 16:

Without replacement of the pump housing at this time, the crowns of the newly positioned gears would not be able to touch the gear bores of the pump housing to cause a seal. (See Fig. 16)

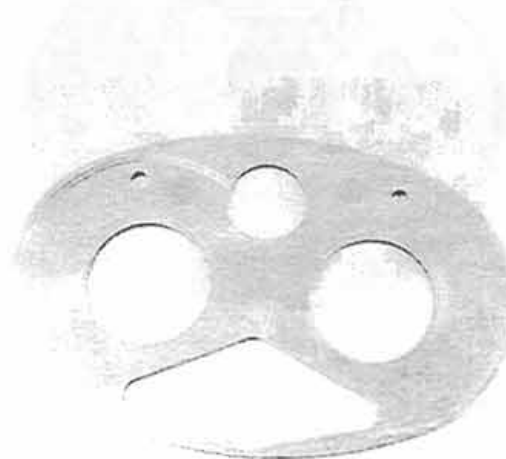
Figure 18:

Slight wear, scratching and discoloration are not considered harmful unless the entire wearing surface is affected. Usually, the center of the plate has a different appearance due to meshing gear teeth rubbing over it. As long as there is no great dimensional change, this is normal. (See Fig. 18)

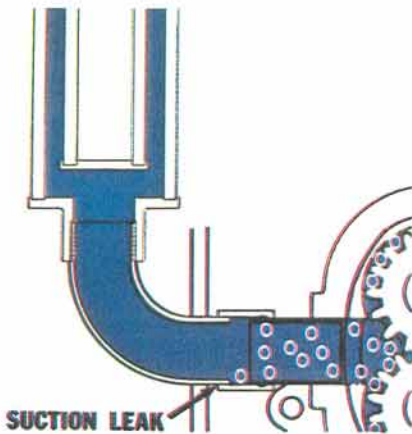
Figure 32:

Aeration is a condition describing oil that is mixed with air. Whether the mixing is done because of a low oil level in the reservoir or a suction leak between the reservoir and pump inlet, the term aeration will apply. (See Fig. 32)

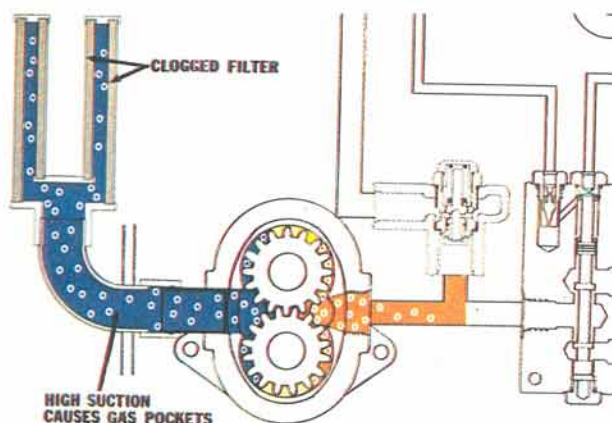
Figure 33:

Cavitation, however, is a term describing a condition seen by the pump when its inlet flow is restricted to a point of partial starvation. If the restriction causes the suction force to be strong enough, it can produce gas bubbles by means of oil vaporization. On both occasions, the pump produces a rattling sound during high free flows, but if demands are put on the pump at this speed, the sound will change to a whine. (See Fig. 33)

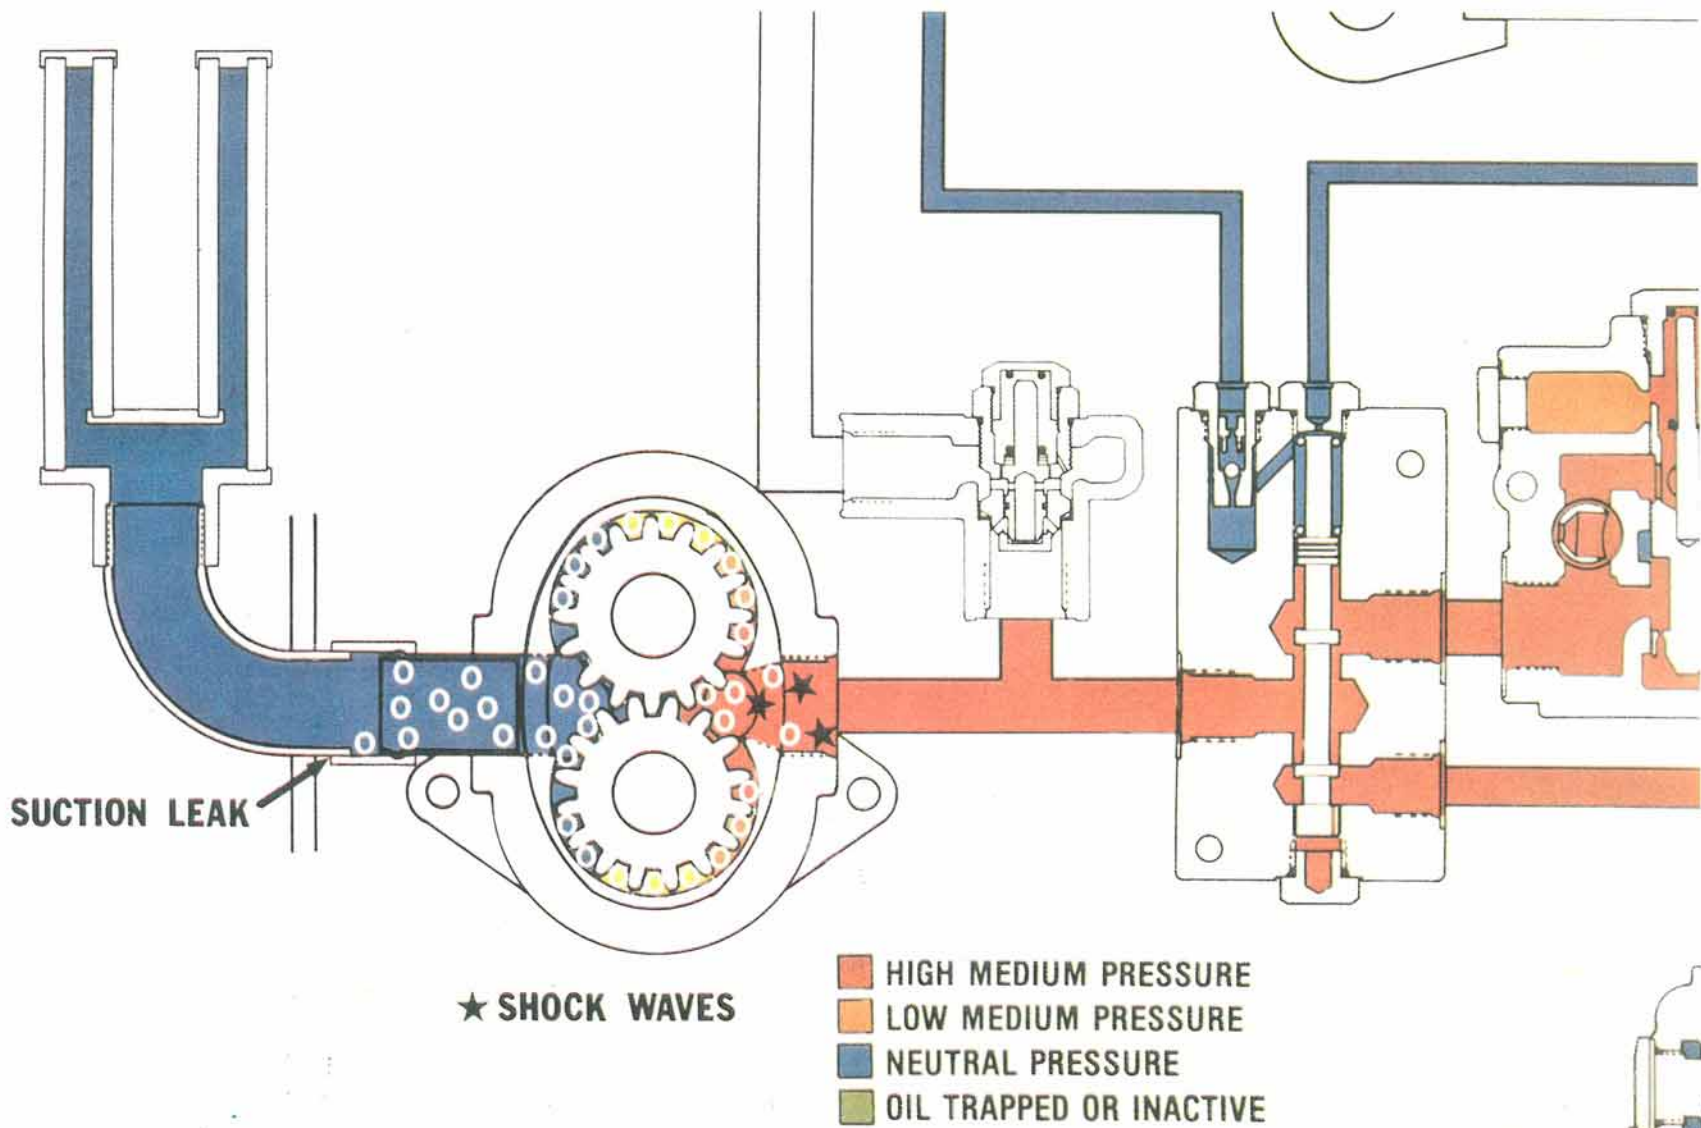
Figure 34:

These forces produce mechanical reactions to cause the noise you hear and also act upon the porous items inside the pump. To better explain this, visualize air or gas bubbles in the stream of oil enroute to the discharge chamber in the pump. When reaching the discharge chamber, the pressure state changes from negative to positive (or suction to discharge) in a very short time span. If any vapors are present when this happens, a violent SLAPPING of the liquid occurs in the discharge chamber as the bubbles are forced to collapse. (See Fig. 34)
